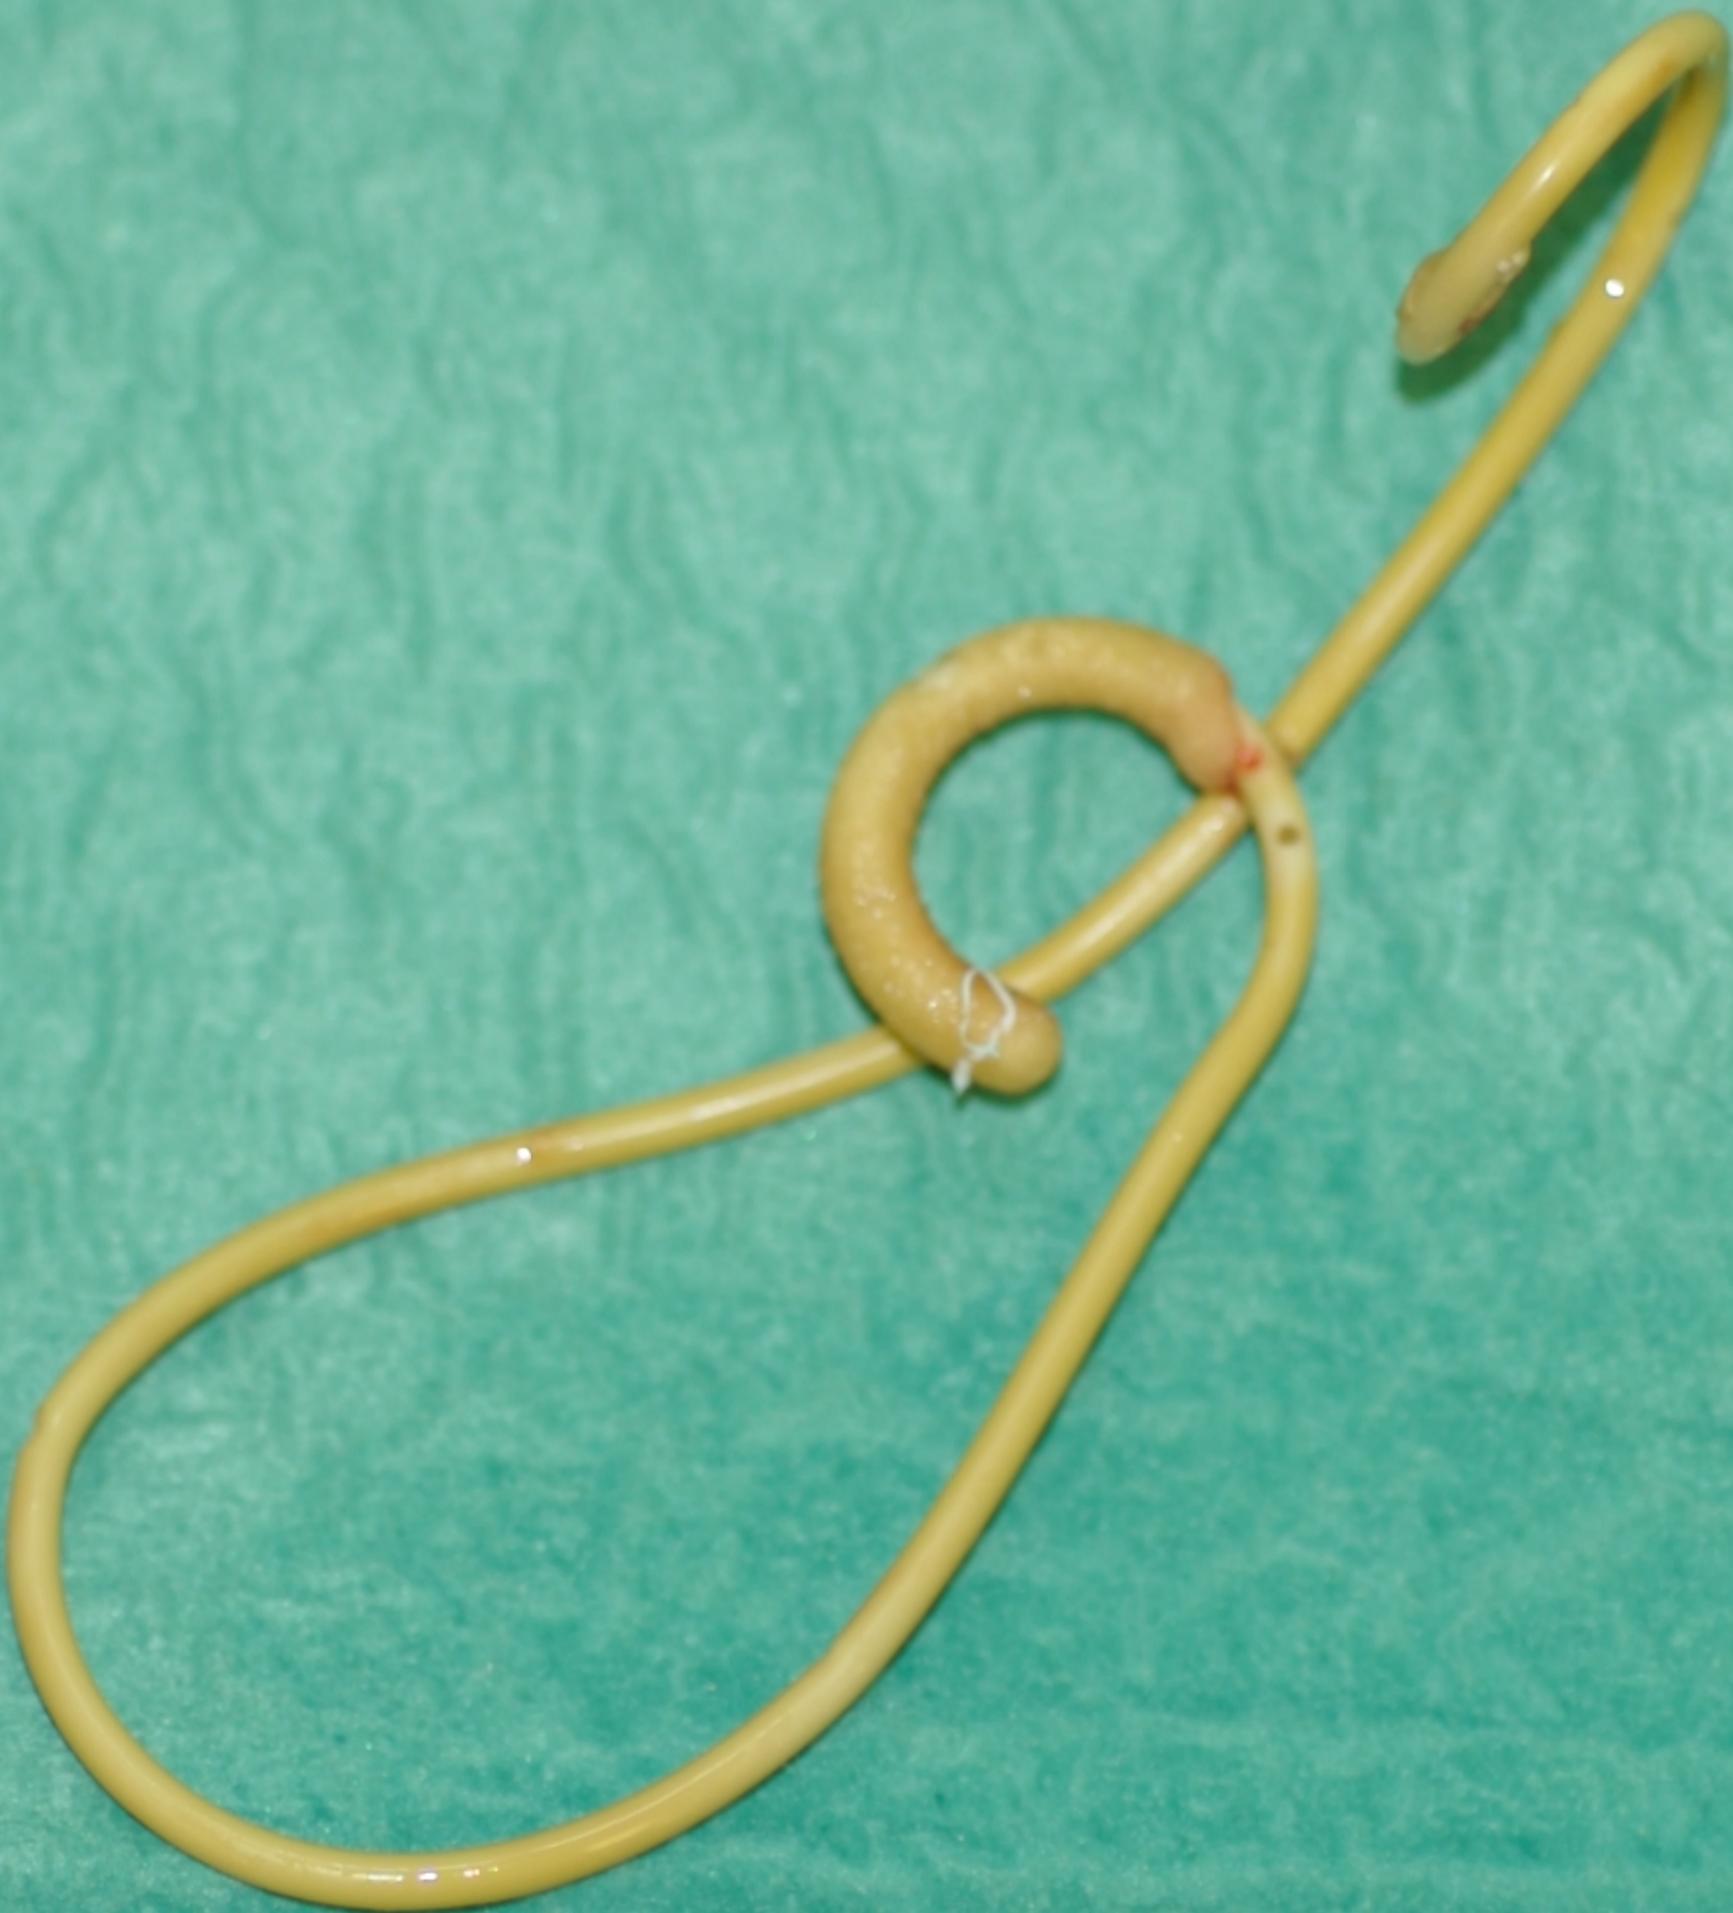
Double J stent removed 6 weeks after a kidney transplant.
Note the encrustation at the bladder end of the stent. It is likely that other calcific debris was left in the renal pelvis and ureter when the stent was removed.
